# Crooked Lake Engineering Feasibility Study

Steuben County, Indiana

April 29, 2005

# **CROOKED LAKE ENGINEERING FEASIBILITY STUDY STEUBEN COUNTY, INDIANA**

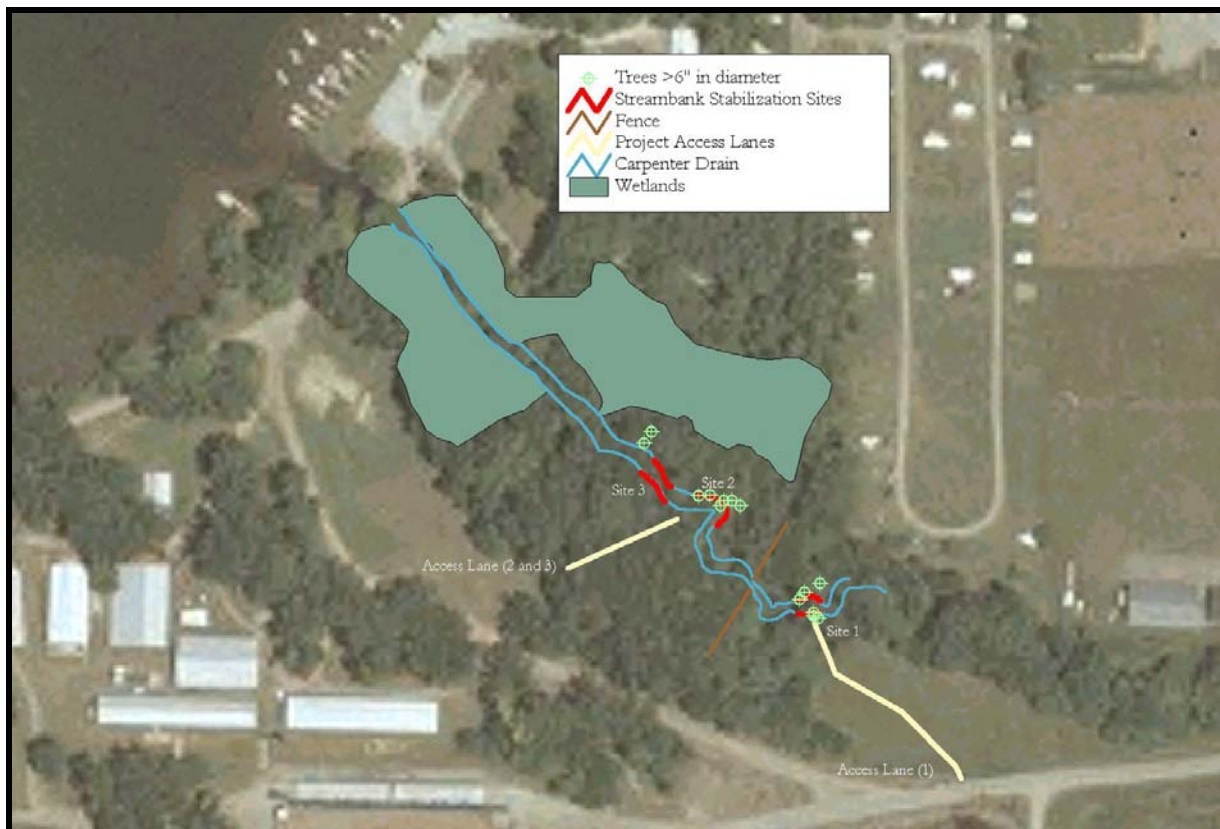
Figure 6. Carpenter Drain bank stabilization project plan view.

Streambank stabilization along Carpenter Drain will consist of the installation of soil-encapsulated lifts and the removal of remnant debris in three locations along the 1,100-foot reach (Figure 6). The first project area (Site 1) is located where an old road crossing and remnant culvert created a cut bank approximately 4 feet high and 30 feet long on the north bank and a cut 3.5 feet high and 20 feet long along the south streambank. The culvert will be removed from the stream and the streambanks reshaped prior to installing soil-encapsulated lifts. A total of 60 lineal feet of streambank stabilization will occur at this site. The second project area (Site 2) occurs where a sharp bend in the stream directs flow into the streambank causing sediment and sediment-attached pollutants to be eroded from the streambank. Approximately 50 lineal feet of soil-encapsulated lifts will be installed along the north bank at this project area. A woody debris jam facilitated streambank erosion along approximately 90 lineal feet at the third project area (Site 3). The log debris jam will be removed, banks reshaped, and soil-encapsulated lifts installed along both the north and south streambanks of this portion of the project site. The total length of bank receiving treatment is approximately 200 lineal feet.

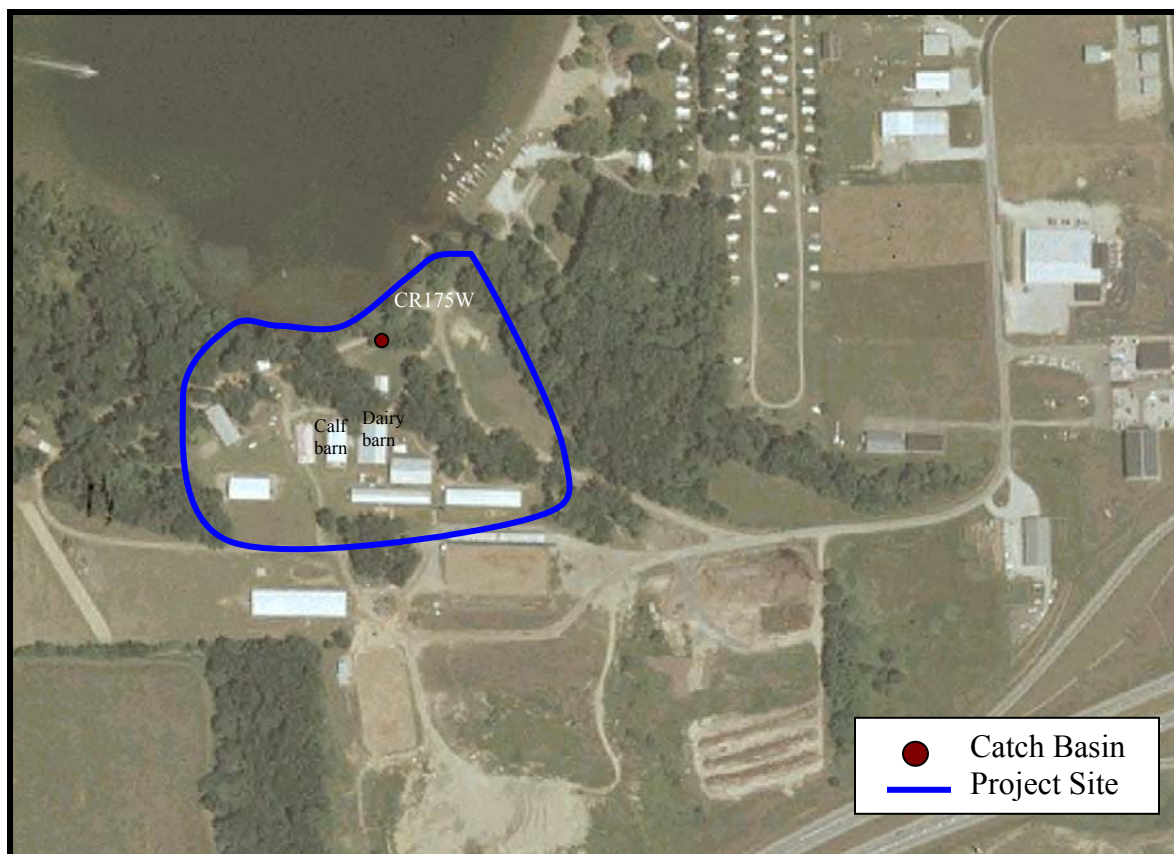
During rain events, water moves across exposed soils and along gravel driveways carrying sediment and sediment-attached pollutants from the Steuben County 4-H Park to Crooked Lake. Stormwater from the eastern portion of the park flows across mowed grass and exposed soils before running down a hill along two gravel driveways. The water then crosses the park entrance road before flowing through an unvegetated swale to Carpenter Drain. Rill and gully erosion present along much of the length of these driveways provides evidence of the rapid transport of water from this portion of the park along the driveways. Stormwater from the western portion of the property flows across mowed grass, unvegetated ground, and down multiple gravel driveways before collecting at a catch basin south of County Road 175 West. This catch basin also collects wash water from the washing station located between the dairy and calf barns (Figure 12). Water flows from the cistern located below the wash stations into a 6-inch plastic pipe to the catch basin. Water exits the catch basin through an 8-inch metal pipe and flows directly into Crooked Lake.

**Figure 12. Stormwater reduction project site at the Steuben County 4-H Park.**

The site currently contributes sediment and sediment-attached pollutants to Crooked Lake during storm events and periods of washing station usage. Additionally, the flow of stormwater down the gravel driveways carries sediment and sediment-attached pollutants to Carpenter Drain. These sediments are accumulating at the mouth of Carpenter Drain forming a sediment delta. A reduction in the volume and velocity of stormwater and wash water flowing across and leaving the site would result in the reduction in the amount of gravel required to maintain the park's roads; the delivery of sediment, phosphorus, and pathogens from dairy wash stations; the amount of sediments and nutrients leaving the site; and the accumulation of sediment at the mouth of Carpenter Drain. Consequently, an improvement in Crooked Lake's water quality would result from stormwater treatment that reduces the volume and velocity of stormwater and wash water leaving the 4-H park.

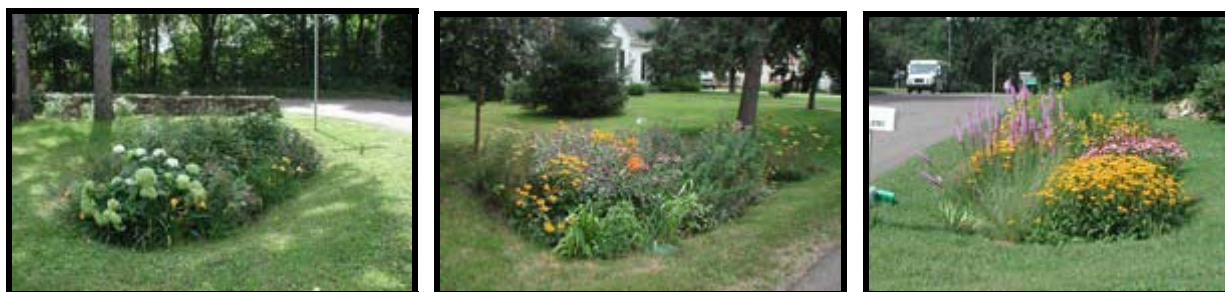
**Figure 17. Representative photographs of conceptual rain garden designs.** Source: Maplewood, Minnesota, 2004.

Two rain gardens will be installed to collect stormwater runoff at the end of the unvegetated swales. One rain garden will be installed near the eastern edge of the 4-H Park, while the second will be installed immediately south of the existing catch basin (Figure 13). Water will enter the

rain gardens as overland flow, through drainage swales adjacent to the existing gravel driveways, and via a drainage swale from the wash water station. Water will leave the eastern rain garden as subsurface flow to Carpenter Drain. Water from the western rain garden will also exit as subsurface flow; however, a pipe connecting the rain garden to the existing catch basin will carry any overflow water to the catch basin, if necessary. Rain gardens are bowl-shaped gardens designed to absorb and filter stormwater (Figure 17). Rain gardens protect lakes and streams from typical lawn fertilizers and pesticides, oil and other fluids from leaking cars, and other pollutants such as sediment and phosphorus from roofs and gravel or paved areas (UWEX, 2003). A rain garden resembles a typical flower garden planted with perennial, deep-rooted native plants and provides landscaping and wildlife habitat while filtering stormwater runoff. Rain gardens are constructed as an oval, with a berm to contain stormwater and mulch to stabilize the surface and reduce weed growth. A variety of perennial plant species can be planted within the rain garden, the exact mix of species will be determined during the design phase of the project.

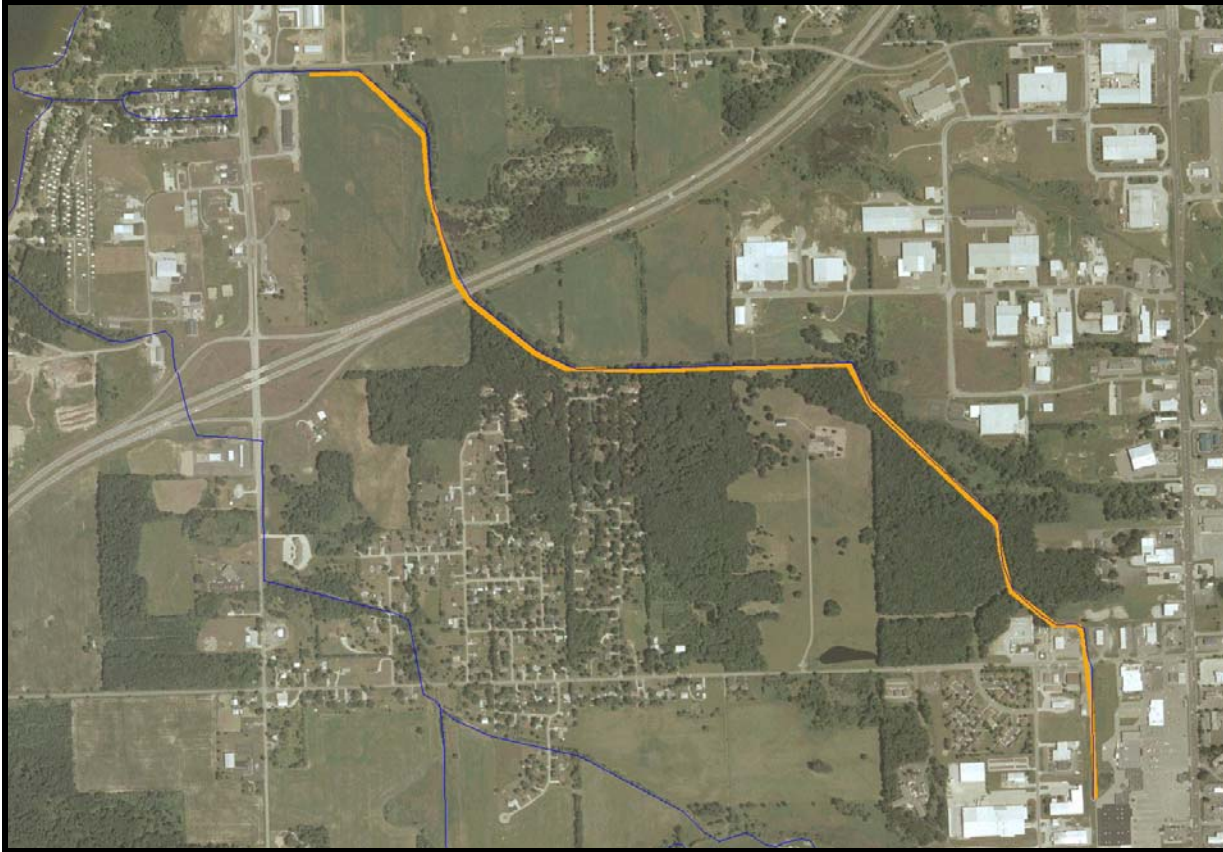
**Figure 18. Stream reconstruction project site (indicated in orange).**

The stream reconstruction project area covers the entirety of Palfreyman Drain from its headwaters to the point where it parallels County Road 200 North (Figure 1). The project includes two series of urban storm drains located 1) south of Country Fair Shopping Center and 2) along Harcourt Road and approximately 10,500 lineal feet (3,200 m) of open drain. The entirety of the open drain included in the project site is marked in orange in Figure 18. Additional storm drains are not marked in Figure 18 but are included in the project site. The stream's watershed has a relatively steep topography falling from 1030 feet mean sea level near the headwaters of Palfreyman Drain to approximately 988 feet mean sea level at the drain's confluence with Crooked Lake. Palfreyman Drain is a legal drain from its intersection with

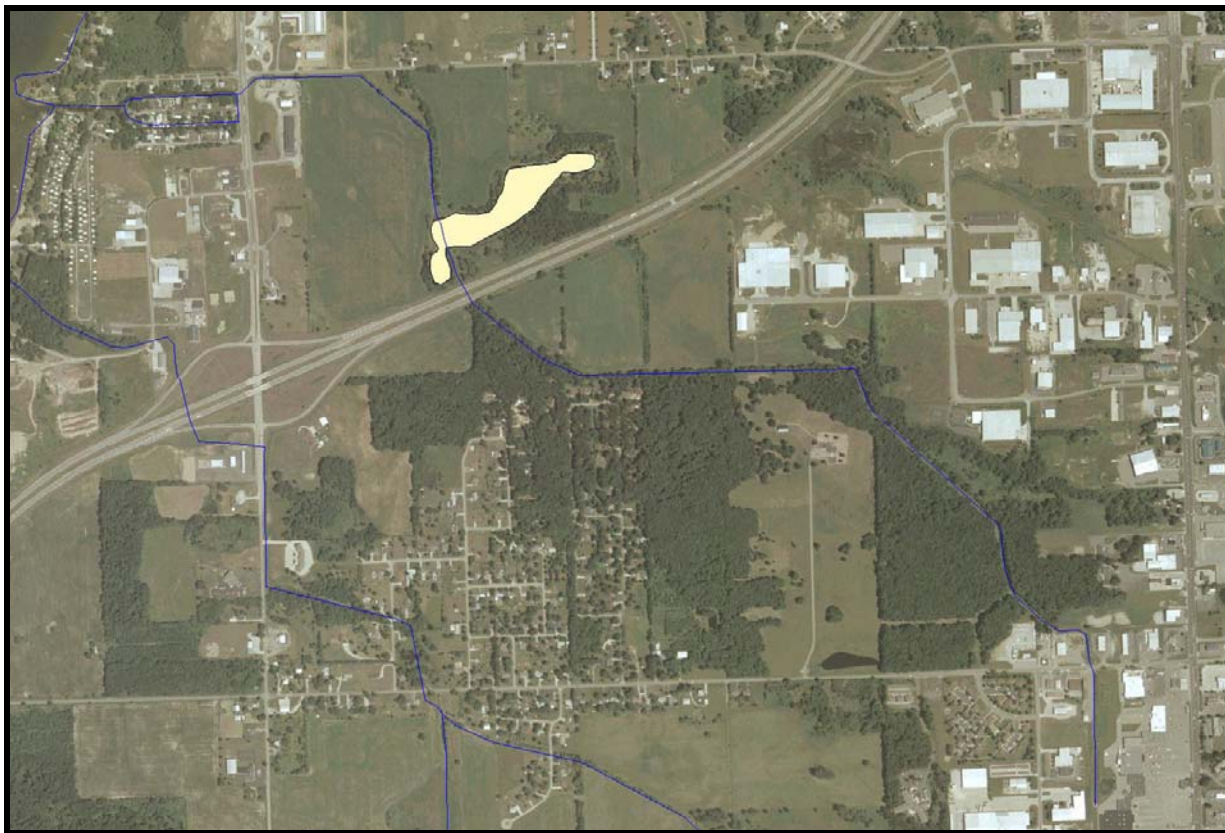
The general location and extent of one wetland was mapped during a field survey conducted on July 20, 2004. Figure 19 shows the approximate location of this wetland area. The wetland is location north of Interstate-69 and lies both east and west of Palfreyman Drain. The wetland is currently utilized as a sediment trap. The sediment trap was constructed in 1999. Dogwood (*Cornus* species), cottonwood (*Populus deltoides*), American elm (*Ulmus americanus*), sedges (*Carex* species), jewelweed (*Impatiens* species), and asters (*Aster* species) vegetate the wetland. The wetland currently serves as good wildlife habitat, provides floodwater storage, and supplies groundwater recharge. None of these will be limited or inhibited by the redesigned channel.

**Figure 19. Approximate wetland boundary within the Palfreyman Drain channel redesign project site.**

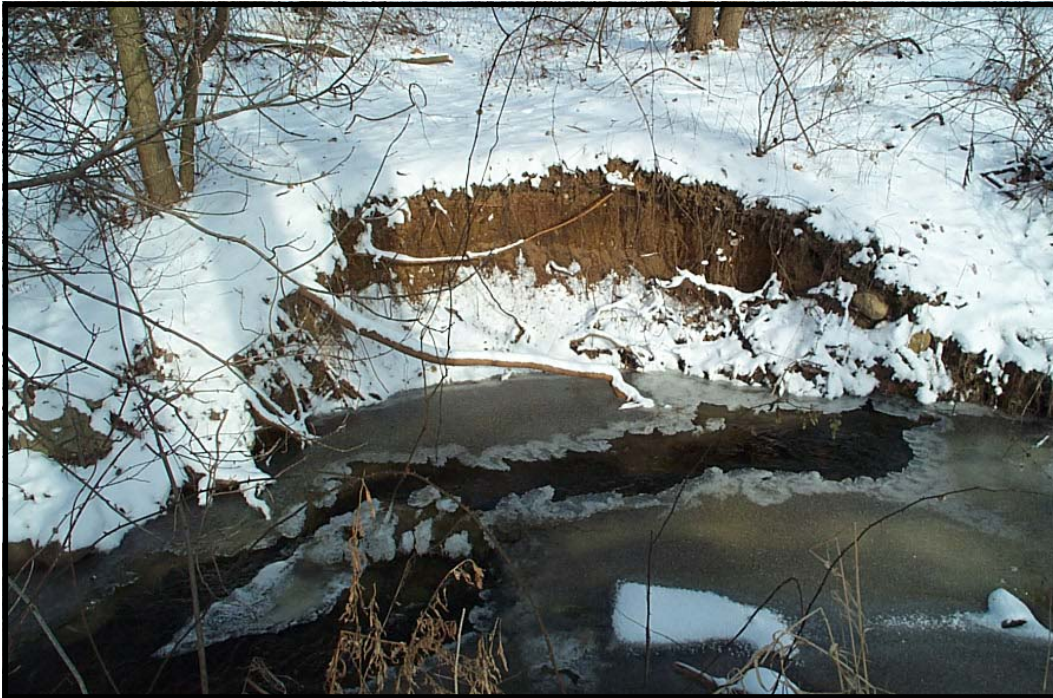
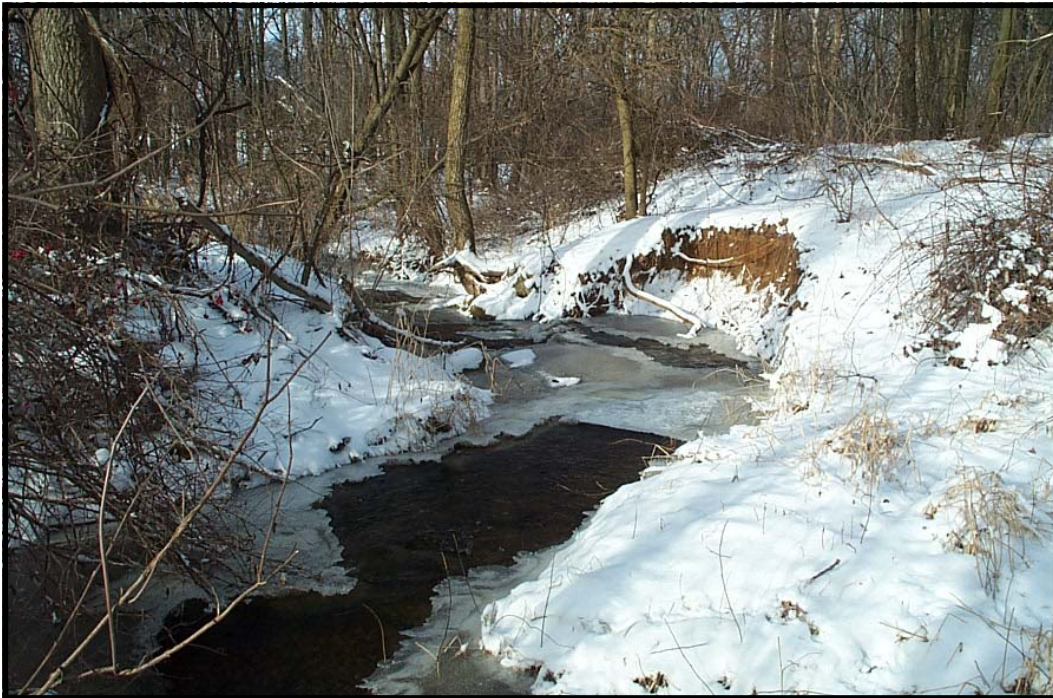
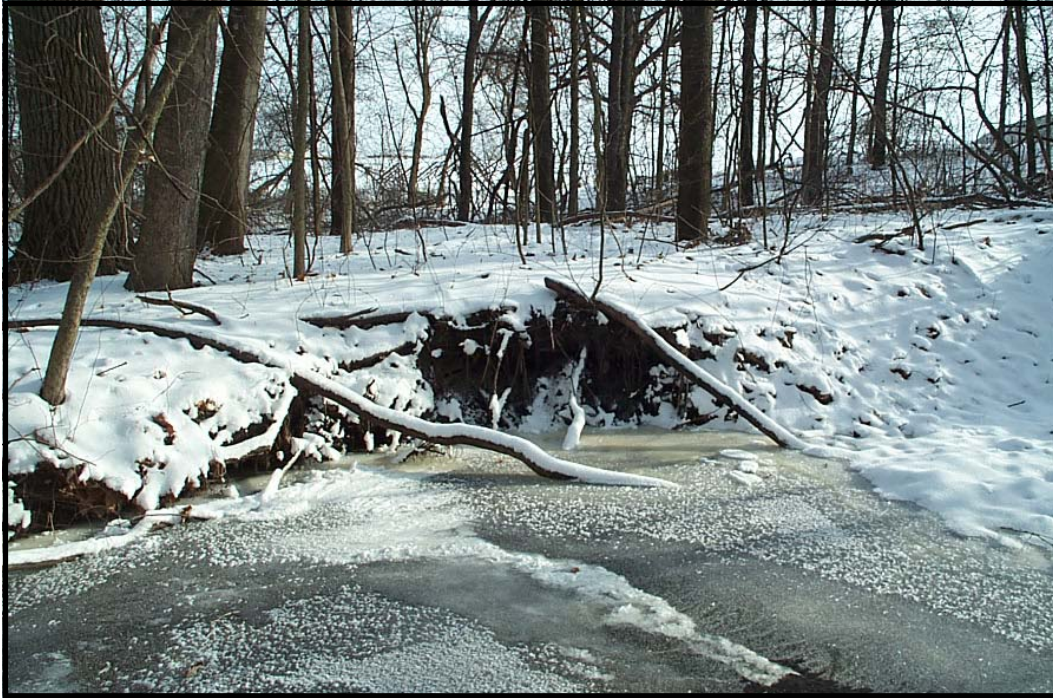
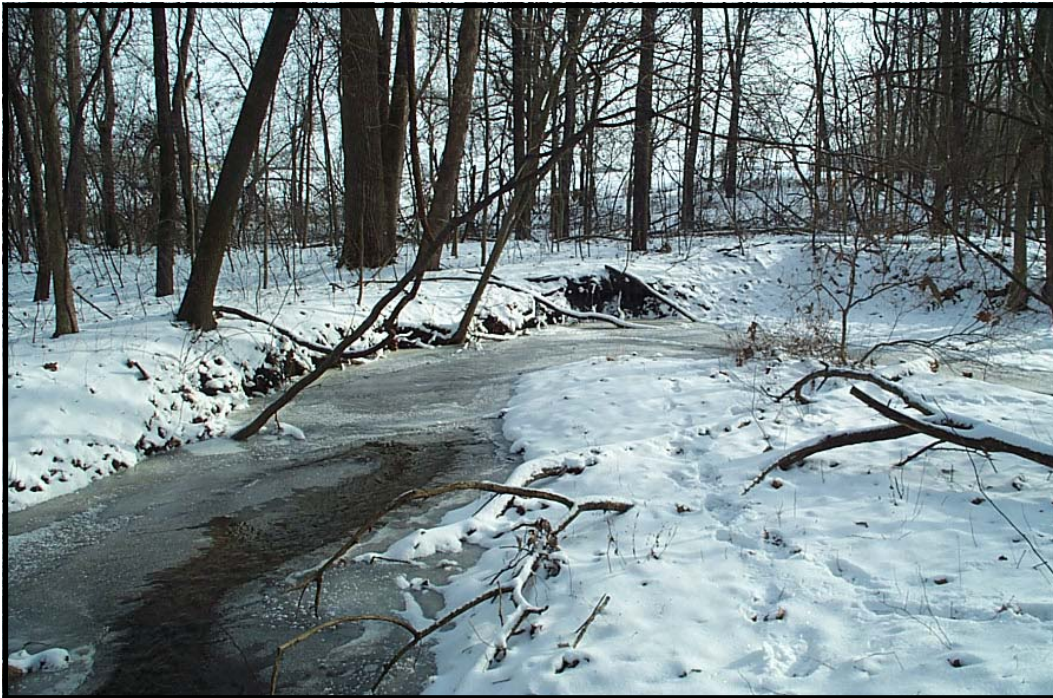
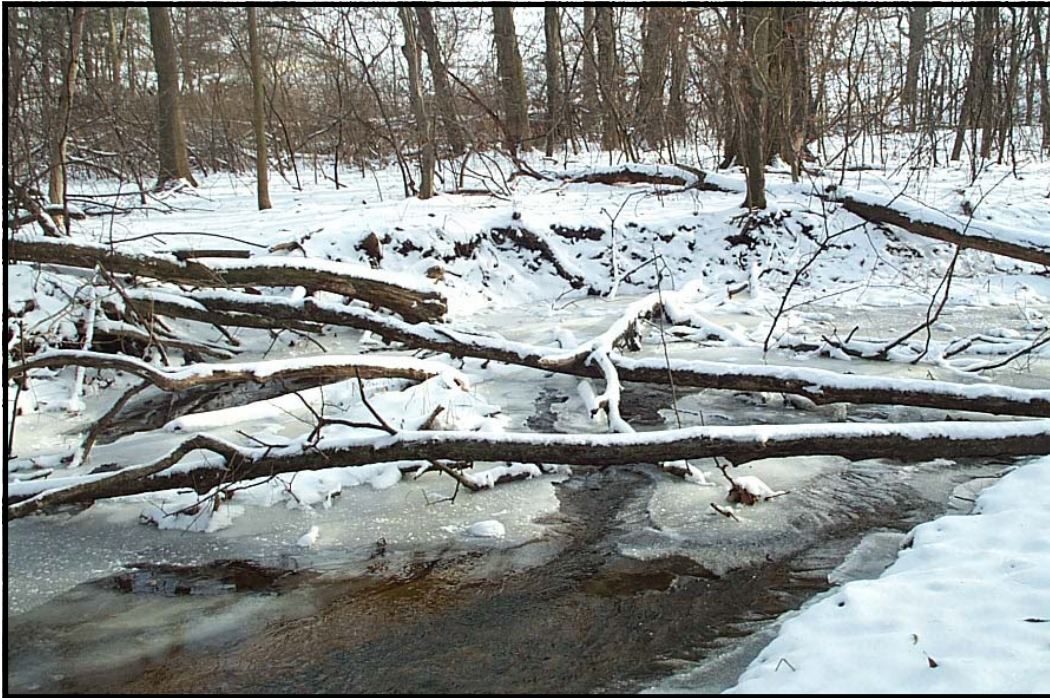
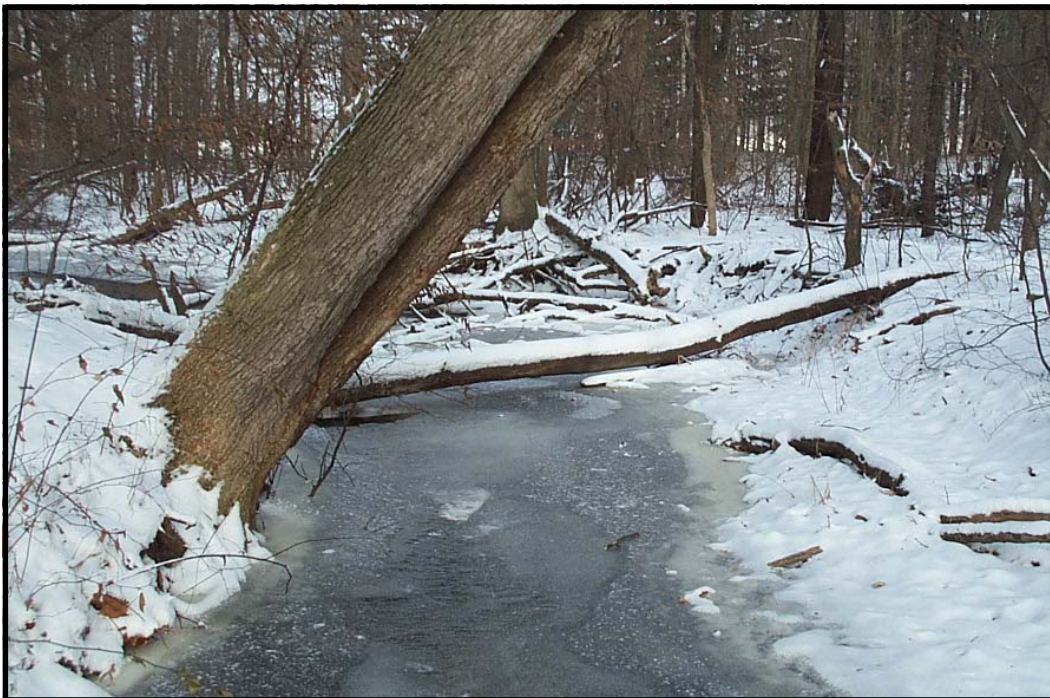
**Bank Erosion Photographs along the Mainstem of Carpenter Drain  
Crooked Lake Engineering Feasibility Report  
Carpenter Drain Bank Stabilization Project  
Steuben County, Indiana**

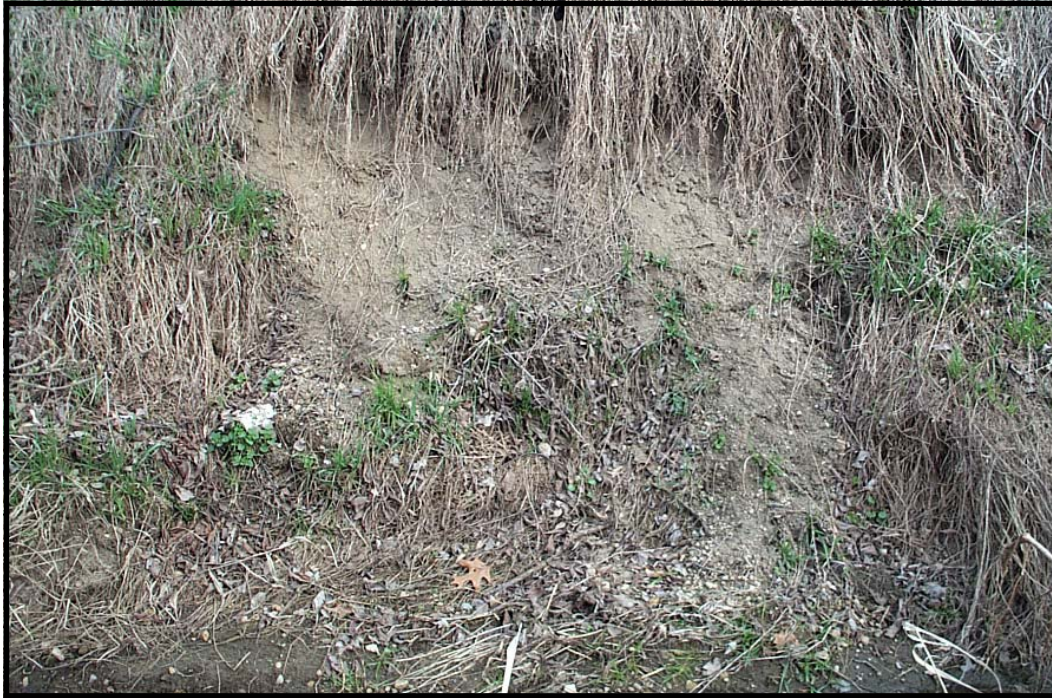
**Erosion along Northern Bank of Palfreyman Drain**

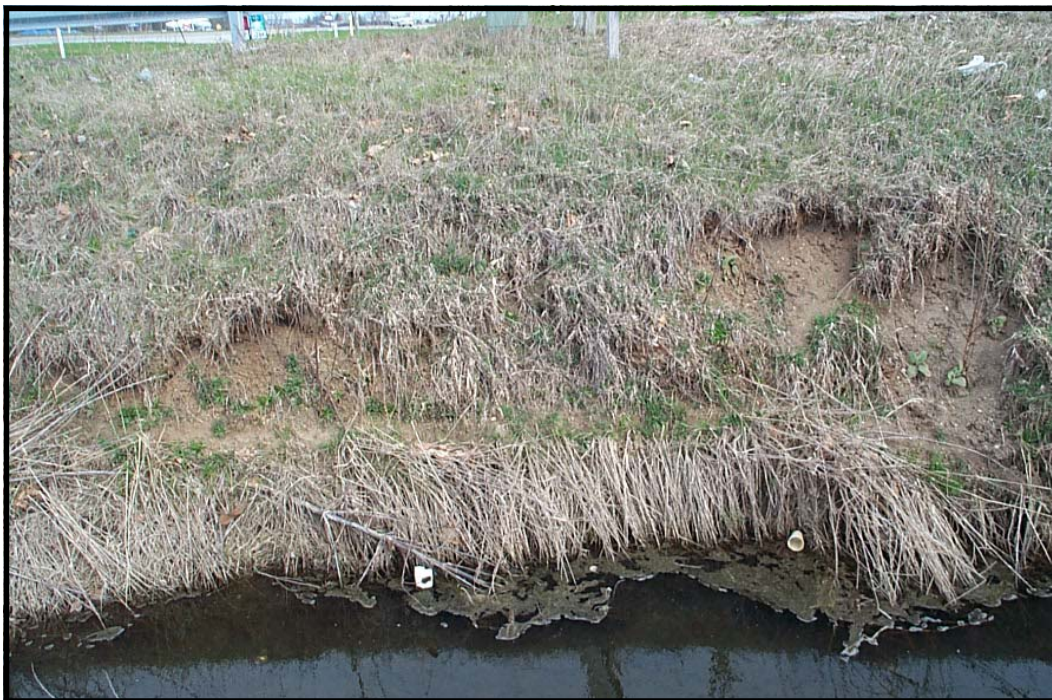
**Erosion along Northern Bank of Palfreyman Drain**

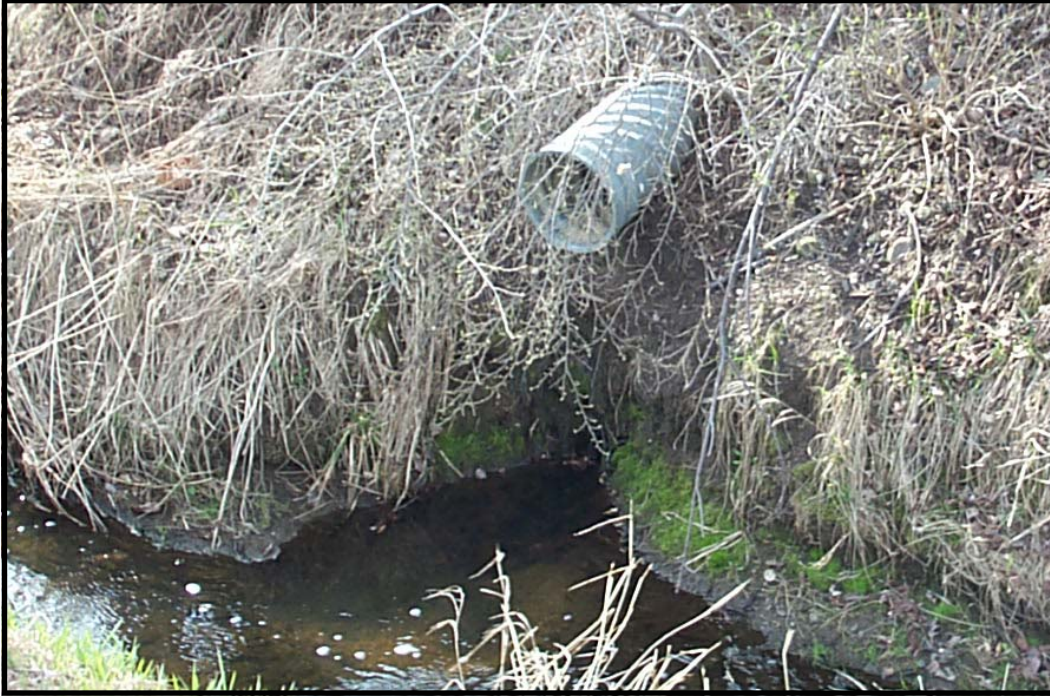
**Vegetated Swale: Existing Pipe and Associated Erosion**

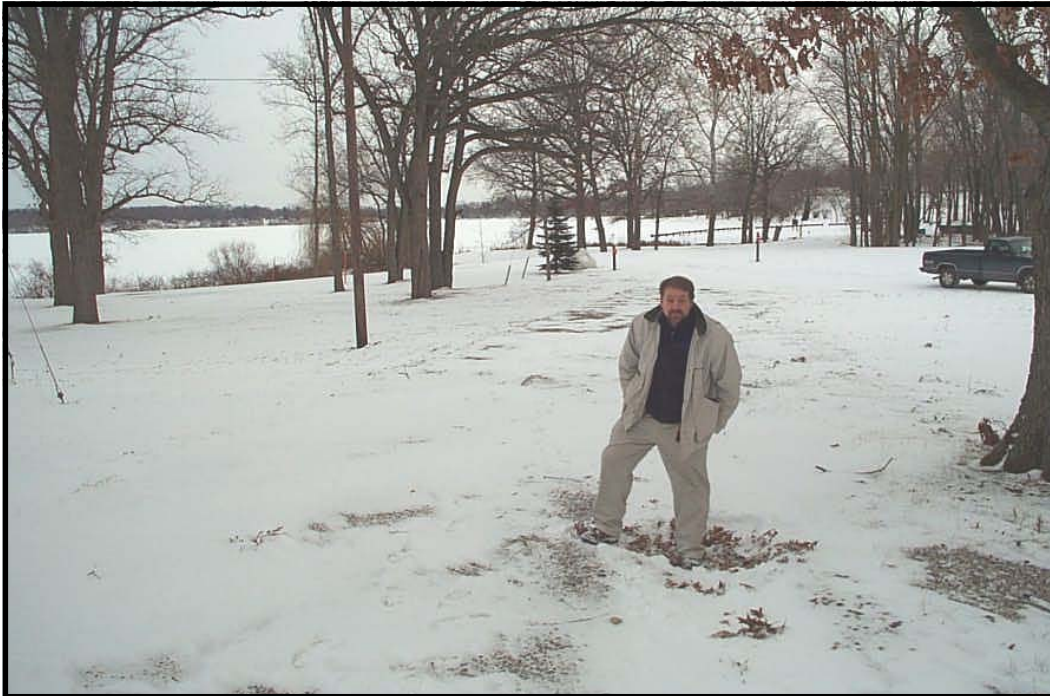
**Gravel Driveway and Washout which Will Drain to East Rain Garden**

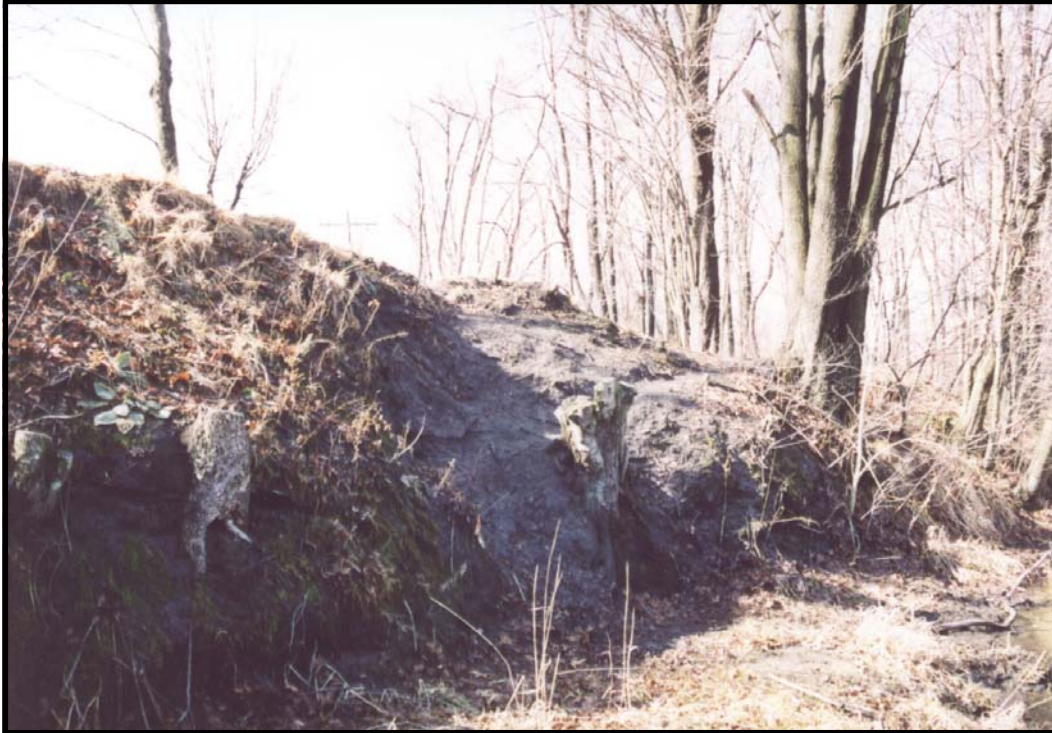
**Example of Gully Erosion Adjacent to Gravel Driveway**

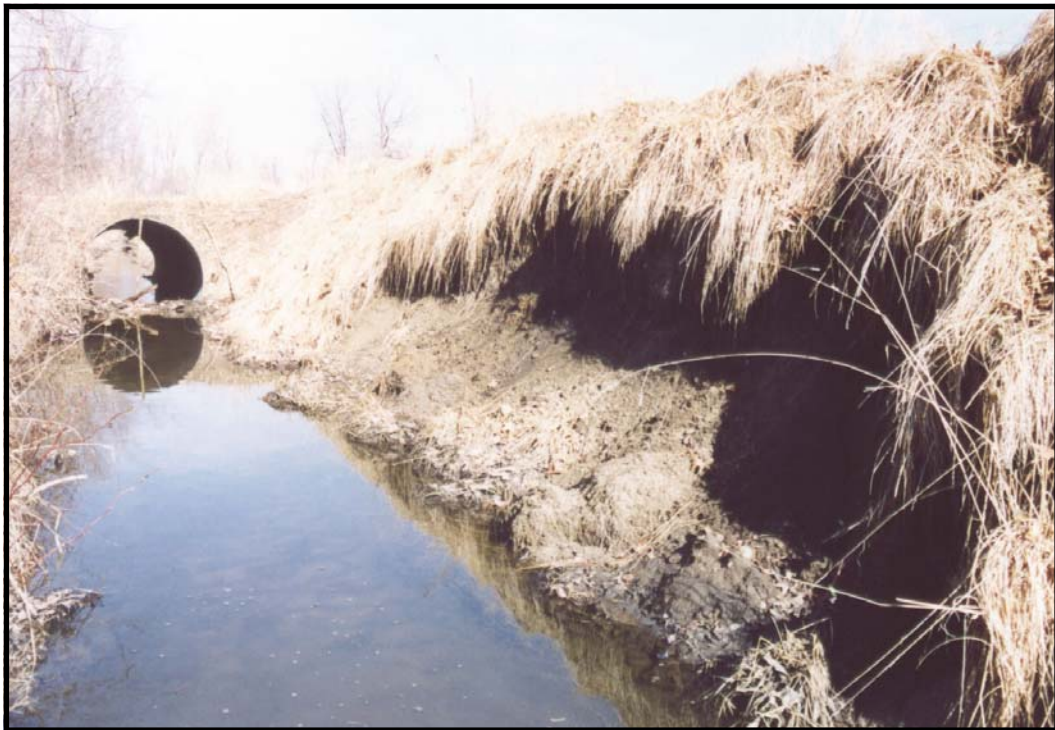
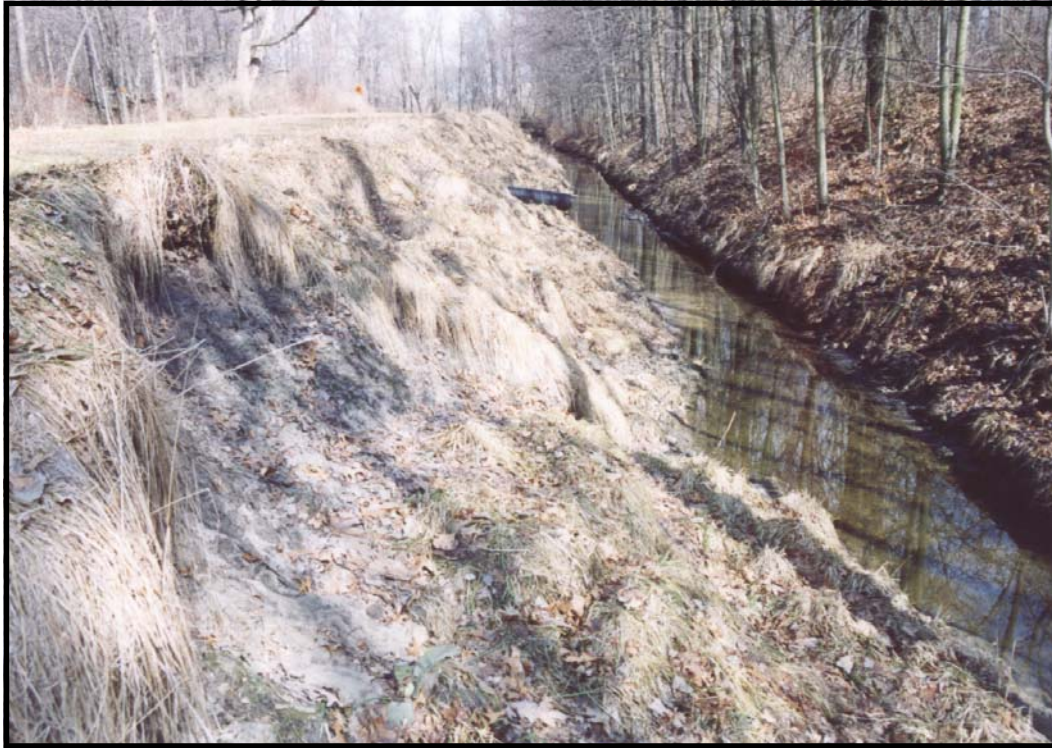
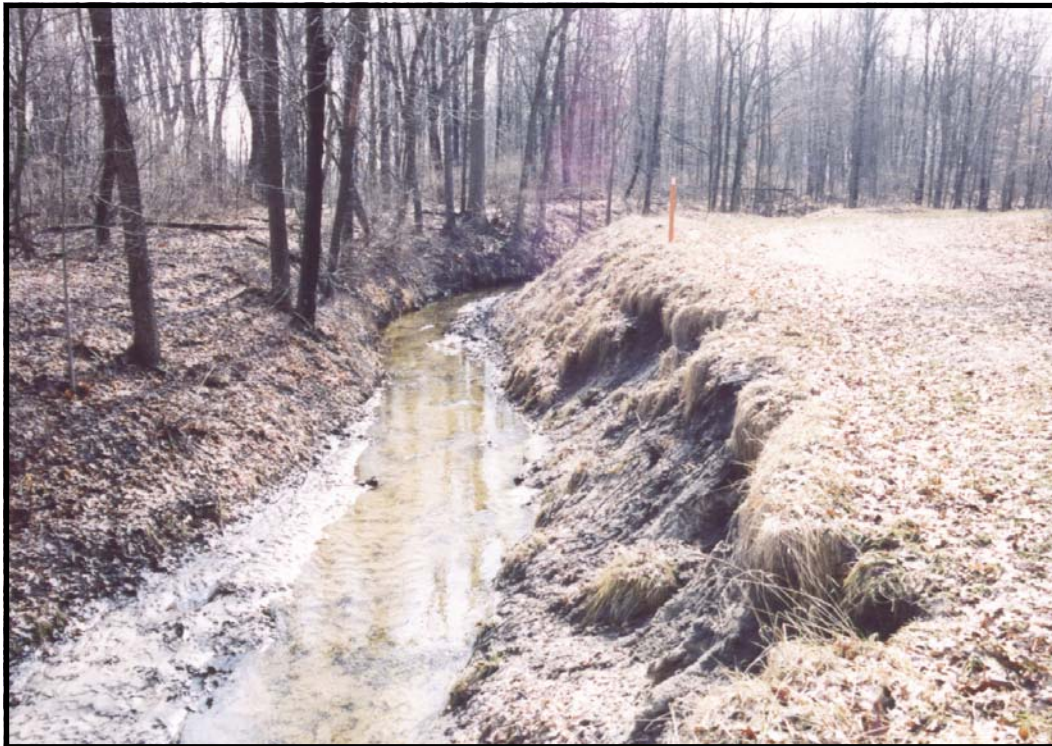
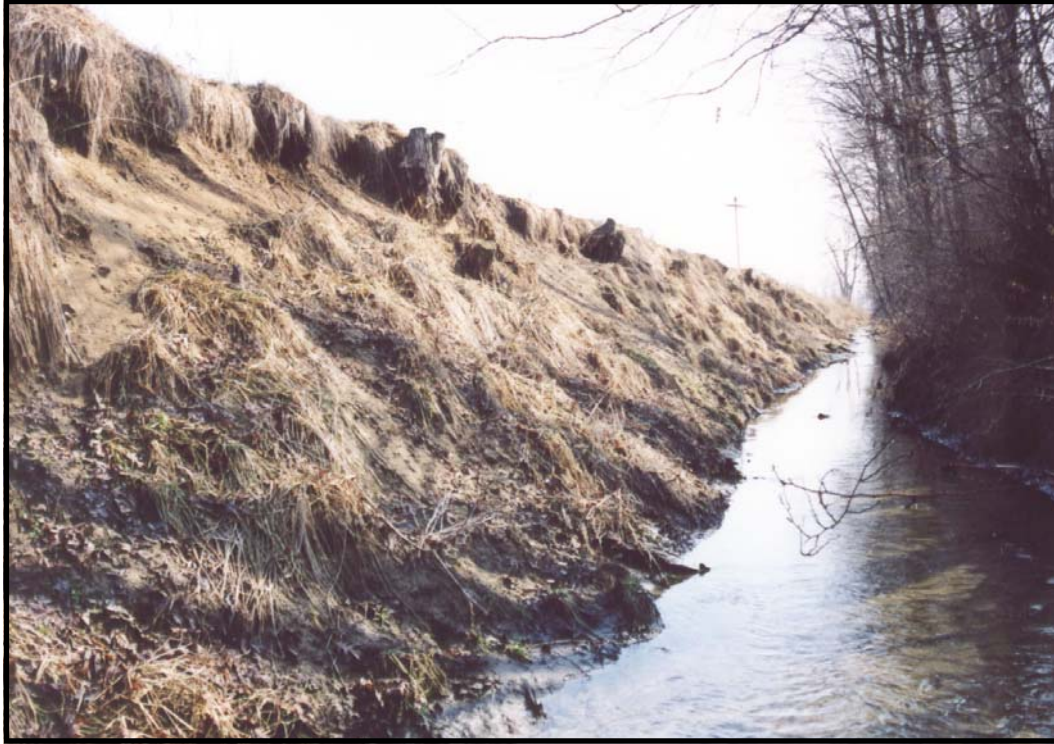
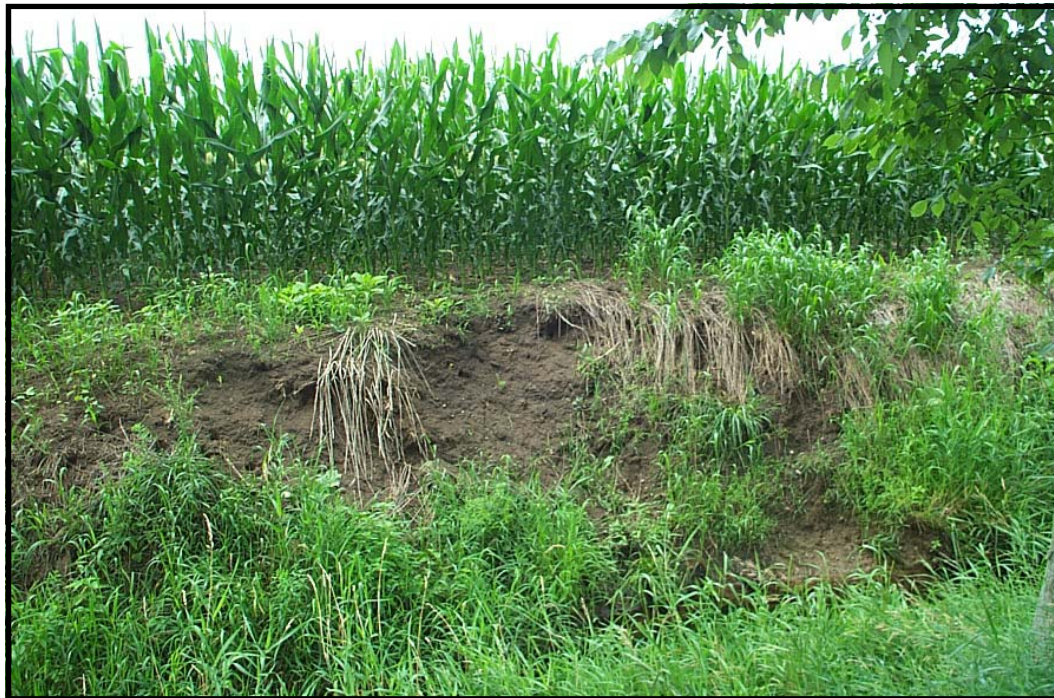
**Streambank Erosion along Palfreyman Drain**

Dredging and straightening of the stream channel and the immediate watershed land use negatively impact Palfreyman Drain. Palfreyman Drain was last cleaned in 1986 (Larry Gilbert, personal communication). At that time, instream work consisted of removing accumulated sediment from the stream channel to maintain adequate drainage of the subwatershed. Since that time, channel erosion and streambank and bed scour have created unstable conditions within the stream. Palfreyman Drain's streambanks are relatively steep measuring 2:1 or 1:1 (horizontal:vertical) along much of the project site. Streambanks measure 7 to 14 feet in height.

The processes of erosion and deposition of bank material continues until the stream reaches a stable condition. In the case of Palfreyman Drain, the relatively steep gradient, sandy soils, and steep streambanks limit the ability of the stream to create stable conditions. Nearly continuous lateral channel migration, bed scour, and bank sloughing results from the unstable conditions present in Palfreyman Drain.
